Images for possible inclusion in book on Livermore Light Bulb

Sandia National Laboratories, Livermore, CA

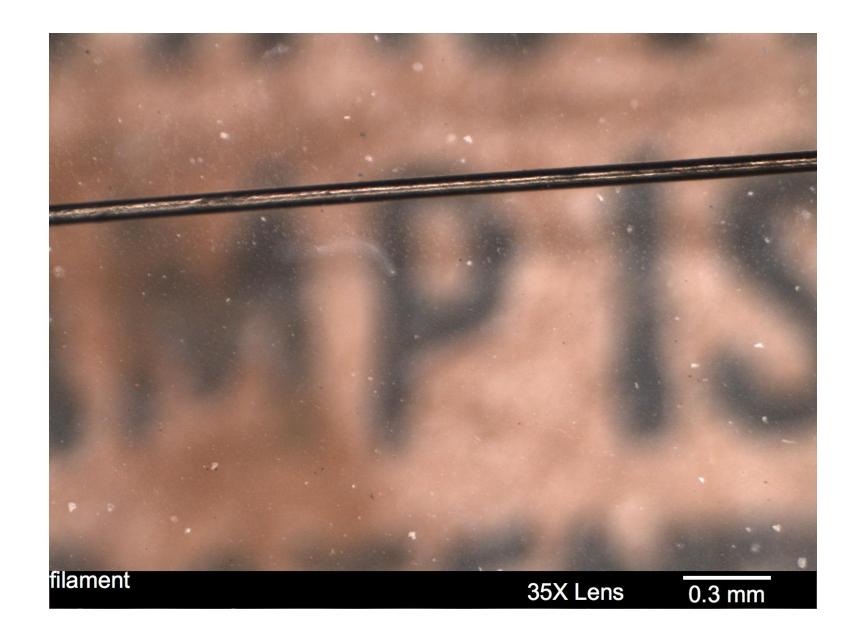
## Optical image of filament with 35x lens

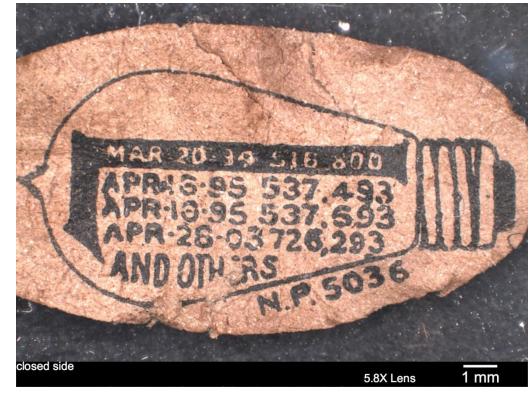
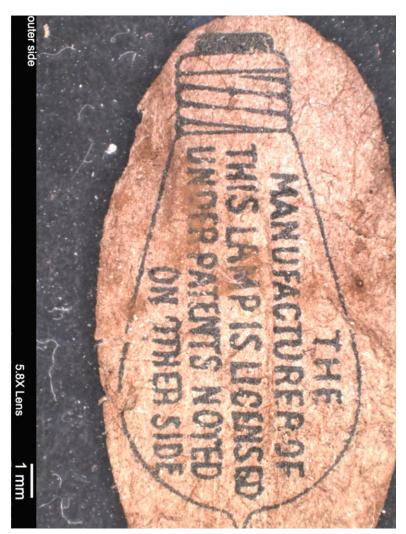
Optical image of paper folded and sealed in glass inside lamp. Top image was the only one visible without breaking glass.

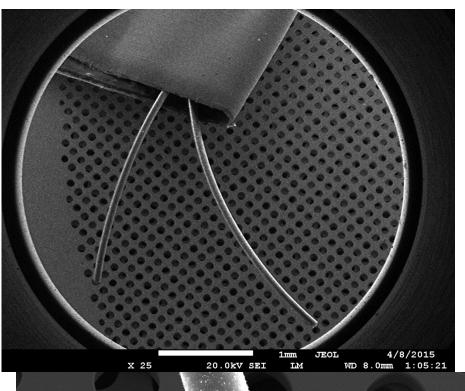
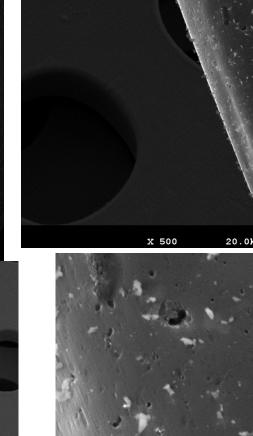
Secondary electron images of filament at 52x, 200x, 500x, 2000x. Analysis by x-ray spectroscopy, which samples microns deep, indicates the filament is carbon. Some of the white

flecks are silica, presumably from the glass.

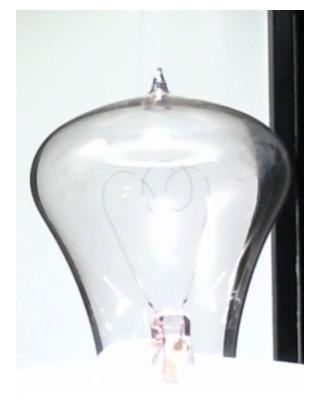
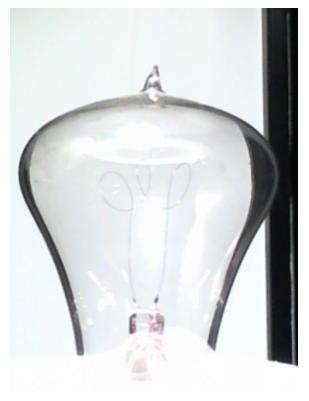
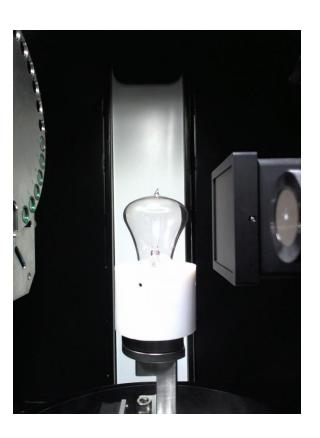
Lamp at two orthogonal orientations in x-ray microscope. X-ray source to left, camera to right.

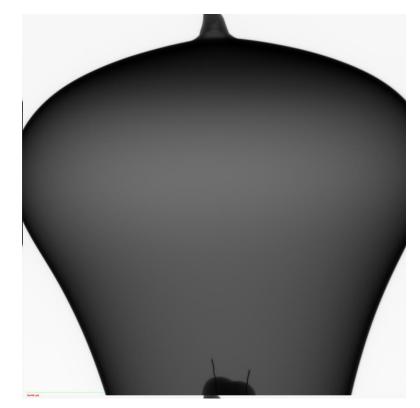
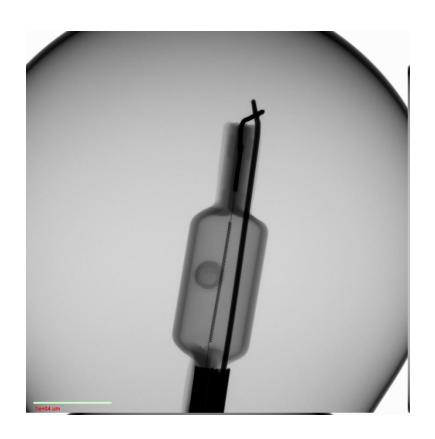
X-ray of old bulb at left compared with new bulb at right shows that the filament cannot be seen through the glass and therefor must be of low atomic number.

The pin to which the filament is attached is easily seen through the glass. The attachment material is not seen.

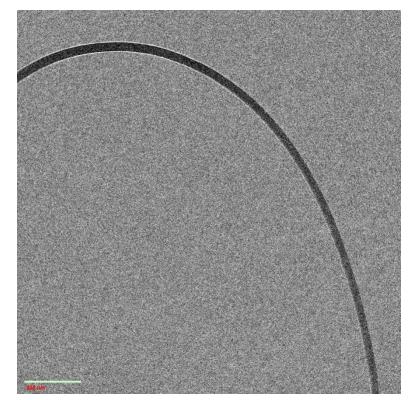
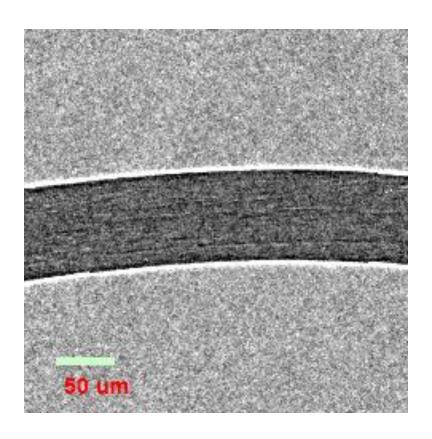
The loops of the filament are seen in an x-ray image. A close-up image allows us to measure the diameter of the filament. The white edge that is seen is the image is from phase contrast.

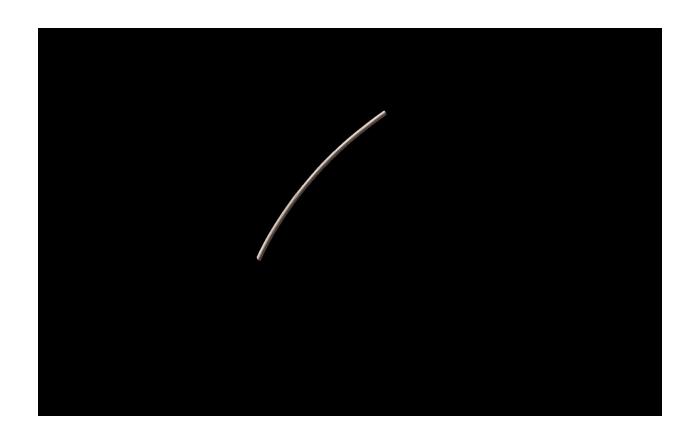
A section of the filament is seen in this three dimensional x-ray image.

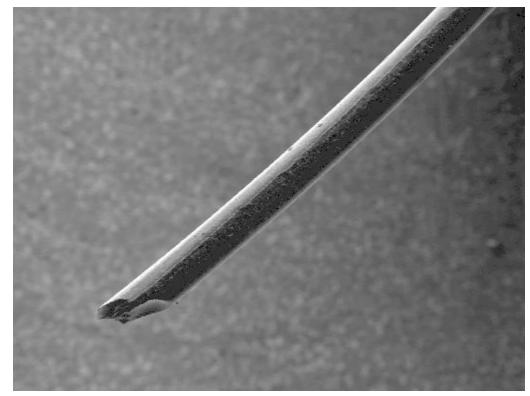
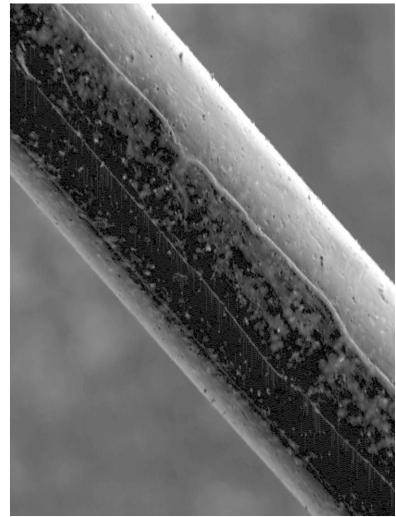
The filament is distinctly round as seen in these three dimensional x-ray images of a section of filament. The lower image highlights the surface texture of the filament. **BEMills**

Auger spectroscopy, which only samples nanometers of the surface, shows the filament to be carbon. This precludes the filament having been plated with some metal.
